**Flood Control Project Maintenance  
Levee Inspections****LMA District Cover Sheet****Spring 2016 Levee Inspection Results****Reclamation District No. 0150 Merrit Island**

**Spring 2016 Levee Inspection Results**

**Reclamation District No. 0150 Merrit Island**

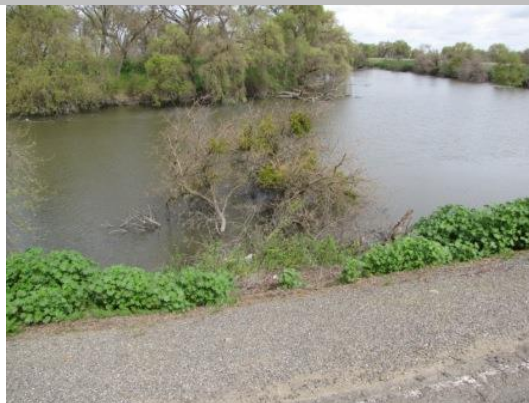
Photo 1 of 1 : SP\_2016\_RD0150\_17\_27\_20160219\_00020.jpg

LM Start	3.34	Rating **	N	Issue No.	27
LM End	3.34	Issue Type +	Ma	Location *	WS
Category	Earthen Levee			GPS Latitude/Longitude	
				Start	End
Item	Trim / Thin Trees			38.363147 °	38.363147 °
				-121.556190 °	-121.556190 °
DWR ID	DWR_RD0150_03_s_2012_27				
Comment Code					
T5 : Tree stumps.					
Inspector Comment

View of tree stumps on the waterside slope looking upstream.

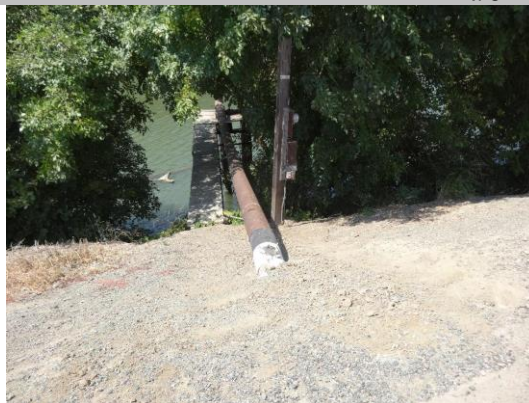
Photo 1 of 2 : UCIP\_SP\_2016\_41729\_35013.jpg

LM Start	3.39	Rating **	M	Issue No.	958
LM End	3.39	Issue Type +	En	Location *	WS
Category	Supplemental			GPS Latitude/Longitude	
				Start	End
Item	DWR UCIP Field Study			38.363520 °	38.363520 °
				-121.555571 °	-121.555571 °
DWR ID					
Comment Code					
Inspector Comment					
FS_ID:41729 DS_ID:22439 EP_NO: N/A Repair Type: Non-Urgent Crossing Status: Found UCIP Comments: Leaky concrete standpipe on landside levee toe creating some erosion.- pump was working at the time of inspection. FIELD_STRUCT_DESC: 8-inch steel pipe through the levee, 3.7 feet below the crown. Service pole on the waterward slope and pump on piling in the stream. Concrete stand pipe on landside levee toe. (A. Pylman) O&M Manual SAC 112, March 1957. FS Date: 8/20/2013

WS view: exposed pipe, walkway, service pole on levee slope and pump support in channel.

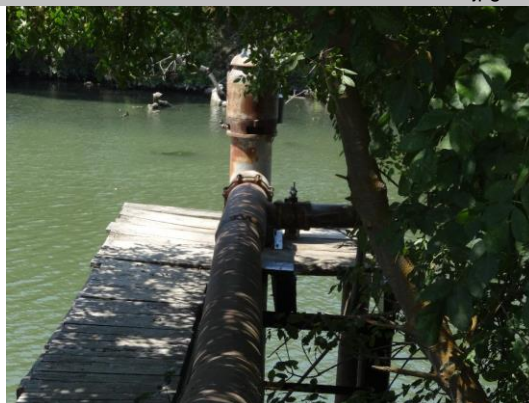
Photo 2 of 2 : UCIP\_SP\_2016\_41729\_35012.jpg

WS view: steel pipe &amp; pump, walkway, pump support in the channel.

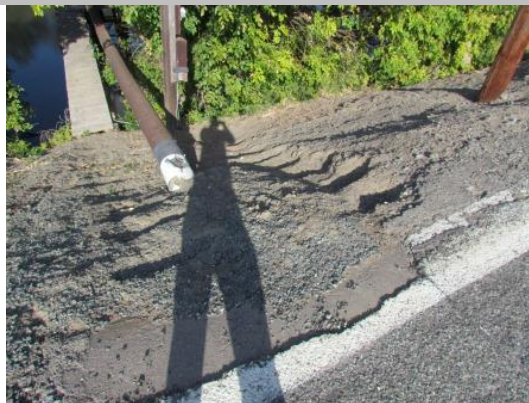
Photo 1 of 1 : SP\_2016\_RD0150\_17\_114\_20160219\_00087.jpg

LM Start	3.39	Rating **	M	Issue No.	114
LM End	3.39	Issue Type +	Ma	Location *	WS
Category	Earthen Levee			GPS Latitude/Longitude	
				Start	End
Item	Encroachments			38.363540 °	38.363540 °
				-121.555555 °	-121.555555 °
DWR ID	DWR_RD0150_03_f_2013_114				
Comment Code					
ST : Stairway					
Inspector Comment

View of steps that were dug on the waterside slope of the levee looking upstream.

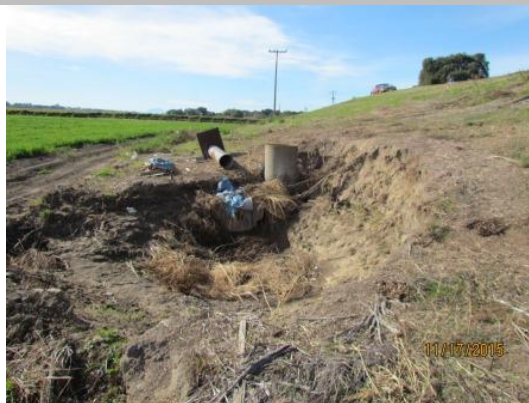
Photo 1 of 2 : SP\_2016\_RD0150\_17\_115\_20160219\_00088.jpg

LM Start	3.39	Rating **	U	Issue No.	115	
LM End	3.39	Issue Type +	Ma	Location *	LS	
Category	Earthen Levee			GPS Latitude/Longitude		
				Start		End
Item	Erosion / Bank Caving			38.363540 °		38.363540 °
				-121.555554 °		-121.555554 °
DWR ID	DWR_RD0150_03_f_2013_115					
Comment Code						
E2 : Schedule repair of erosion site prior to the next inspection.						
Inspector Comment						
Erosion (ditch) was found on the landside toe of the levee.

Updated picture of the ditch on the landside toe of the levee during fall 2015 inspection.

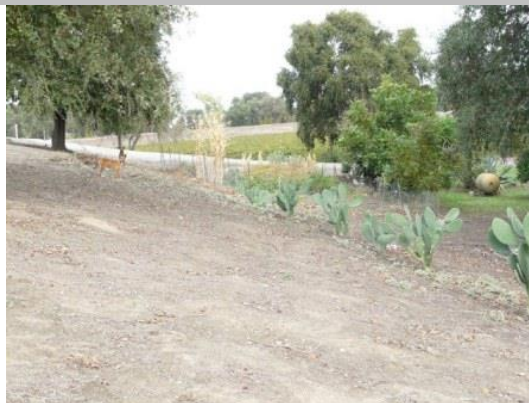
Photo 1 of 1 : SP\_2016\_RD0150\_17\_47\_20160219\_00040.jpg

LM Start	3.44	Rating **	M	Issue No.	47
LM End	3.48	Issue Type +	En	Location *	LS
Category	Earthen Levee			GPS Latitude/Longitude	
				Start	End
Item	Vegetation			38.364251 °	38.364772 °
				-121.555321 °	-121.555343 °
DWR ID	DWR_RD0150_03_s_2012_47				
Comment Code					
V6 : Landscaping					
Inspector Comment

Landscaping &amp; garden on landward slope of levee at LM 3.50 to LM 3.54.

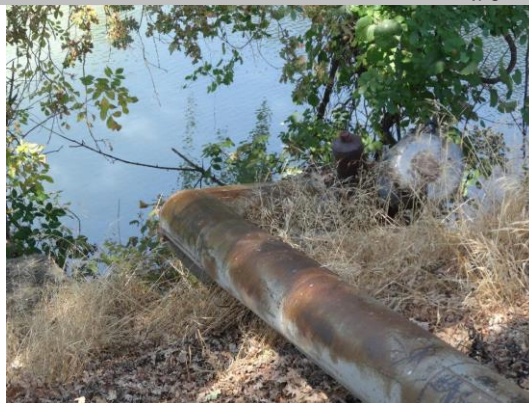
Photo 1 of 2 : UCIP\_SP\_2016\_20766\_35018.jpg

LM Start	3.66	Rating **	U	Issue No.	956
LM End	3.66	Issue Type +	En	Location *	WS
Category	Supplemental			GPS Latitude/Longitude	
				Start	End
Item	DWR UCIP Field Study			38.367213 °	38.367213 °
				-121.555273 °	-121.555273 °
DWR ID					
Comment Code					
Inspector Comment					
FS_ID:20766					
DS_ID:22440					
EP_NO: N/A					
Repair Type: Urgent					
Crossing Status: Found					
UCIP Comments: Concrete standpipe on LS. Levee damage.Gate valve on WS not found.Safety valve on WS pipe.					
FIELD_STRUCT_DESC: 12-inch steel pipe through the levee, 5.9 feet below the crown. Pump on the waterward slope. Concrete standpipe at the landward toe. (R. & J. Pylman) O&M Manual SAC 112, March 1957.					
FS Date: 8/20/2013

WS view: steel pipe and pump on levee slope.

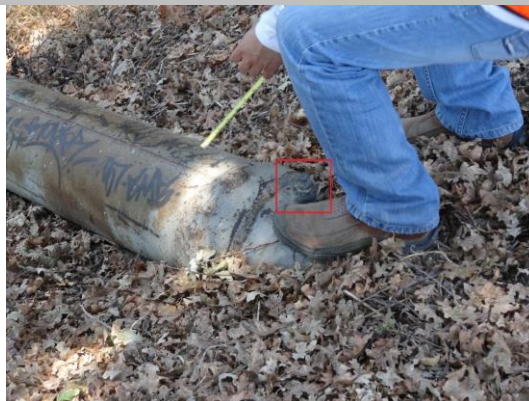
Photo 2 of 2 : UCIP\_SP\_2016\_20766\_35021.jpg

WS view: steel pipe with safety valve (marked) on levee slope.

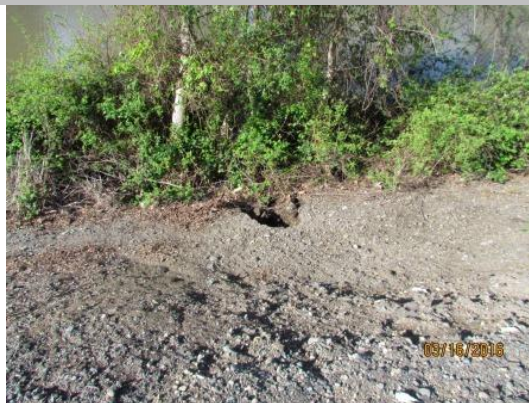
Photo 1 of 1 : SP\_2016\_RD0150\_17\_93\_20160321\_00147.jpg

LM Start	4.02	Rating **	M	Issue No.	93
LM End	4.02	Issue Type +	Ma	Location *	WS
Category	Earthen Levee			GPS Latitude/Longitude	
				Start	End
Item	Erosion / Bank Caving			38.370125 °	38.370125 °
				-121.552030 °	-121.552030 °
DWR ID	DWR_RD0150_03_s _ 2016_93				
Comment Code					
E1 : Note and monitor erosion site.					
Inspector Comment					
Erosion on the waterside toe of the levee.

An erosion was found on the waterside toe of the levee.

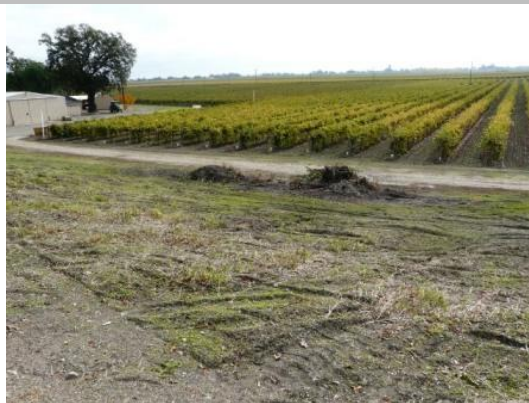
Photo 1 of 4 : SP\_2016\_RD0150\_17\_51\_20160219\_00044.jpg

LM Start	4.38	Rating **	M	Issue No.	51
LM End	4.38	Issue Type +	En	Location *	LS
Category	Earthen Levee			GPS Latitude/Longitude	
				Start	End
Item	Encroachments			38.374269 °	38.374269 °
				-121.549385 °	-121.549385 °
DWR ID	DWR_RD0150_03_s _ 2012_51				
Comment Code					
PR : Prunings					
Inspector Comment

Remove pruning pile on landward slope at LM 4.46.

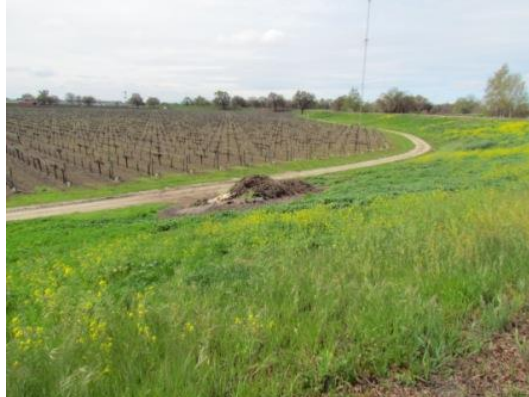
Photo 2 of 4 : SP\_2016\_RD0150\_17\_51\_20160219\_00045.jpg

Prunings were found on the landside of the levee looking downstream.

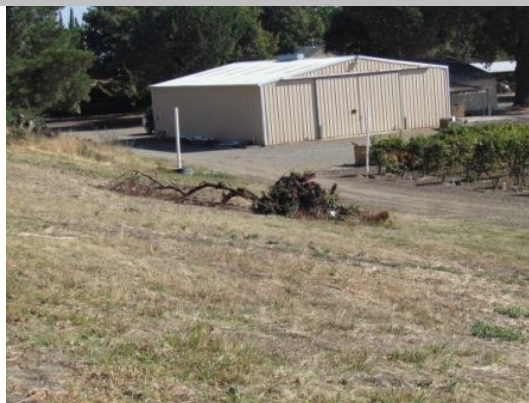
Photo 3 of 4 : SP\_2016\_RD0150\_17\_51\_20160219\_00046.jpg

Prunings were found on the landside of the levee looking upstream. This picture was taken during fall 2012 inspection.

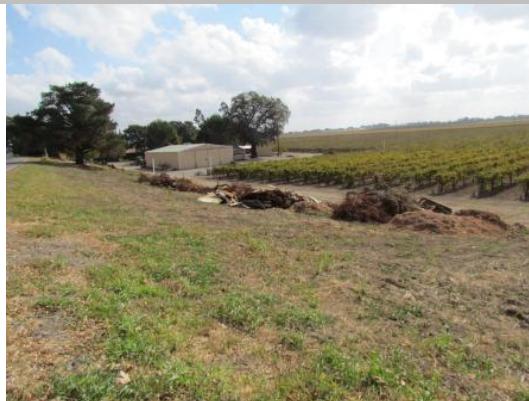
Photo 4 of 4 : SP\_2016\_RD0150\_17\_51\_20160219\_00047.jpg

Updated picture of the pruning pile on the landside of the levee looking upstream during the fall 2013 inspection.

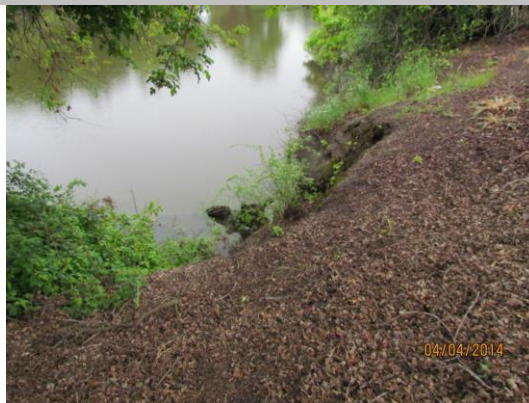
Photo 1 of 1 : SP\_2016\_RD0150\_17\_80\_20160219\_00075.jpg

LM Start	4.49	Rating **	U	Issue No.	80
LM End	4.49	Issue Type +	Ma	Location *	WS
Category	Earthen Levee			GPS Latitude/Longitude	
				Start	End
Item	Erosion / Bank Caving			38.374355 °	38.374355 °
				-121.547436 °	-121.547436 °
DWR ID	DWR_RD0150_03_s_2014_80				
Comment Code					
E2 : Schedule repair of erosion site prior to the next inspection.					
Inspector Comment

View of an erosion site on the waterside toe of the levee looking upstream.

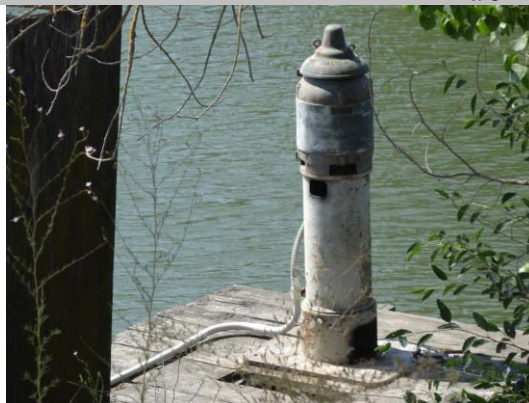
Photo 1 of 2 : UCIP\_SP\_2016\_19281\_32541.jpg

LM Start	4.63	Rating **	M	Issue No.	953
LM End	4.63	Issue Type +	En	Location *	LS
Category	Supplemental			GPS Latitude/Longitude	
				Start	End
Item	DWR UCIP Field Study			38.374934 °	38.374934 °
				-121.545029 °	-121.545029 °
DWR ID					
Comment Code					
Inspector Comment					
FS_ID:19281					
DS_ID:22444					
EP_NO: N/A					
Repair Type: Non-Urgent					
Crossing Status: Found					
UCIP Comments: - service pole on LS. 1" conduit on WS.- levee toe cut out on landside.- walkway and gate.					
FIELD_STRUCT_DESC: 10-inch steel pipe through the levee, 3.8 feet below the crown, pump on piling in stream. Concrete standpipe at the landward toe. (P. Cook) O&M Manual SAC 112, March 1957.					
FS Date: 8/20/2013

WS view: vertical pump on deck.

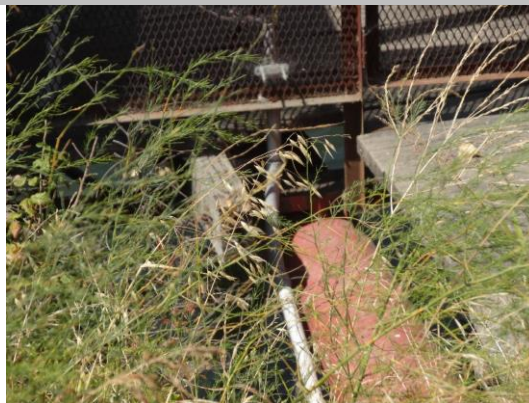
Photo 2 of 2 : UCIP\_SP\_2016\_19281\_32540.jpg

WS view: 1-inch GI conduit (left) and steel pipe (right)

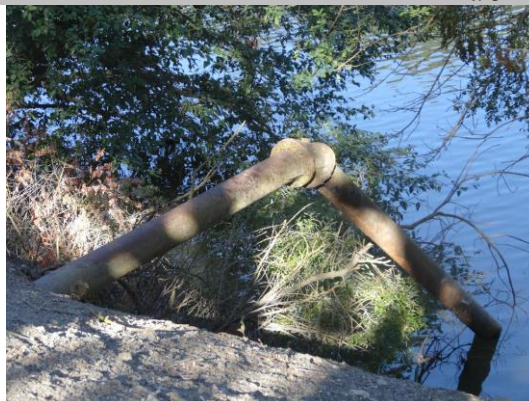
Photo 1 of 2 : UCIP\_SP\_2016\_19283\_32565.jpg

LM Start	4.90	Rating **	M	Issue No.	954
LM End	4.90	Issue Type +	En	Location *	LS
Category	Supplemental			GPS Latitude/Longitude	
				Start	End
Item	DWR UCIP Field Study			38.377718 °	38.377718 °
				-121.541413 °	-121.541413 °
DWR ID					
Comment Code					
Inspector Comment					
FS_ID:19283					
DS_ID:22445					
EP_NO: N/A					
Repair Type: Non-Urgent					
Crossing Status: Found					
UCIP Comments: - seems abandoned.- may need proper abandonment					
FIELD_STRUCT_DESC: Abandoned 10-inch steel pipe through the levee, 7.2 feet below the crown, gate valve on the landward end. (D. Conner) O&M Manual SAC 112, March 1957.					
FS Date: 8/23/2013

WS view: steel pipe on levee slope and in the stream.

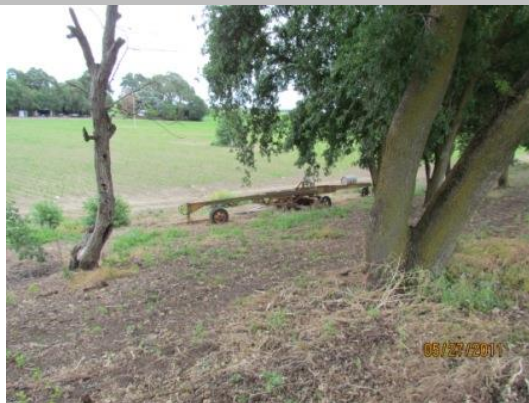
Photo 1 of 1 : SP\_2016\_RD0150\_17\_9\_20160219\_00007.jpg

LM Start	4.91	Rating **	M	Issue No.	9
LM End	4.91	Issue Type +	En	Location *	LS
Category	Earthen Levee			GPS Latitude/Longitude	
				Start	End
Item	Encroachments			38.377761 °	38.377761 °
				-121.541319 °	-121.541319 °
DWR ID	DWR_RD0150_03_s_2012_9				
Comment Code					
EQ : Equipment					
Inspector Comment

Equipment on the landside toe of the levee. The picture was taken from crown looking downstream.

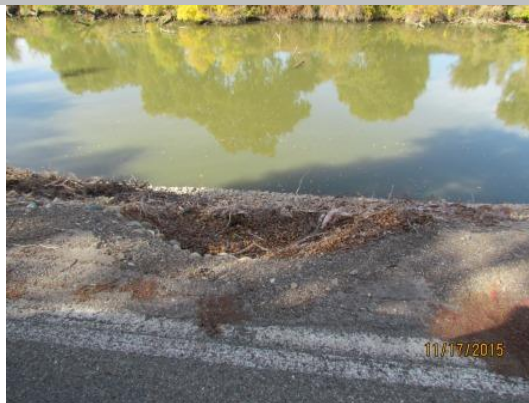
Photo 1 of 2 : SP\_2016\_RD0150\_17\_36\_20160219\_00030.jpg

LM Start	4.99	Rating **	M	Issue No.	36
LM End	4.99	Issue Type +	Ma	Location *	WS
Category	Earthen Levee			GPS Latitude/Longitude	
				Start	End
Item	Slope Stability			38.378771 °	38.378771 °
				-121.540538 °	-121.540538 °
DWR ID	DWR_RD0150_03_f_2012_36				
Comment Code					
S1 : Repair slope instability.					
Inspector Comment

Updated picture of the slope instability of the waterside shoulder of the levee during fall 2015 inspection.

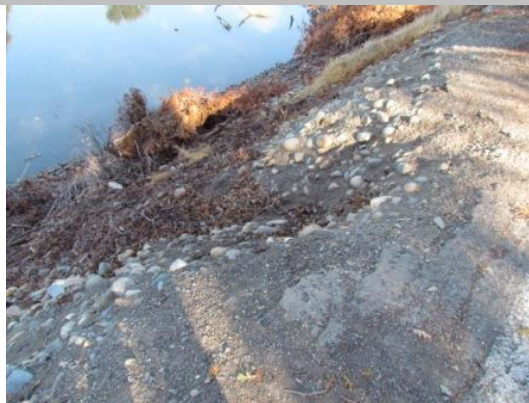
Photo 2 of 2 : SP\_2016\_RD0150\_17\_36\_20160219\_00031.jpg

Slope instability was found on the waterside of the levee looking upstream.

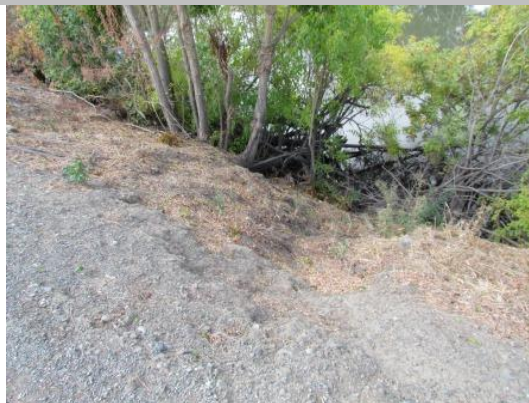
Photo 1 of 2 : SP\_2016\_RD0150\_17\_4\_20160219\_00003.jpg

LM Start	5.04	Rating **	M	Issue No.	4
LM End	5.04	Issue Type +	Ob	Location *	WS
Category	Earthen Levee			GPS Latitude/Longitude	
				Start	End
Item	Slope Stability			38.379456 °	38.379456 °
				-121.540147 °	-121.540147 °
DWR ID	DWR_RD0150_03_s_2012_4				
Comment Code					
S1 : Repair slope instability.					
Inspector Comment

Updated picture of the slope instability on the waterside slope of the levee looking downstream during the fall 2013 inspection.

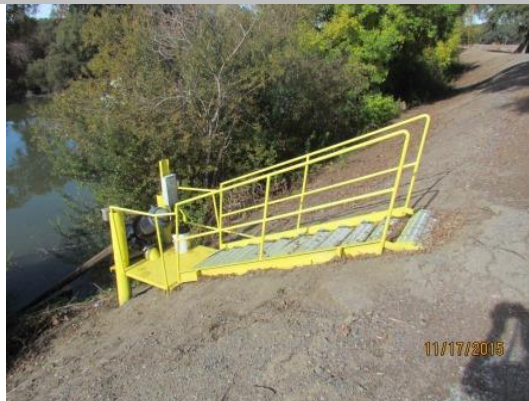
Photo 1 of 1 : SP\_2016\_RD0150\_17\_48\_20160219\_00041.jpg

LM Start	5.09	Rating **	M	Issue No.	48
LM End	5.09	Issue Type +	En	Location *	WS
Category	Earthen Levee			GPS Latitude/Longitude	
				Start	End
Item	Encroachments			38.380110 °	38.380110 °
				-121.540061 °	-121.540061 °
DWR ID	DWR_RD0150_03_f_2015_48				
Comment Code					
ST : Stairway					
Inspector Comment					
Unpermitted stairway.

View of a stairway on the waterside of the levee.

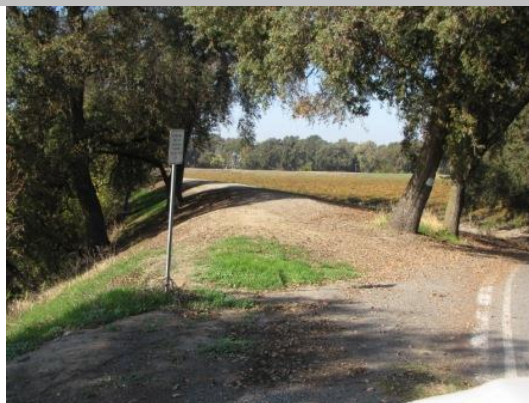
Photo 1 of 1 : SP\_2016\_RD0150\_17\_941\_20160219\_00098.jpg

LM Start	5.14	Rating **	M	Issue No.	941	
LM End	5.14	Issue Type +	Ma	Location *	CR	
Category	Earthen Levee			GPS Latitude/Longitude		
				Start		End
Item	Crown Surface / Depressions / Rutting			38.380779 °		38.380779 °
				-121.540264 °		-121.540264 °
DWR ID	DWR_RD0150_03_s_2012_941					
Comment Code						
C2 : Repair depressions or ruts in the crown or slope.						
Inspector Comment						
There is a significant difference in the crown roadway elevation as it transitions from the paved roadway to the gravel access road.

View of varying elevations in the crown of the levee at the transition from county road to access road.

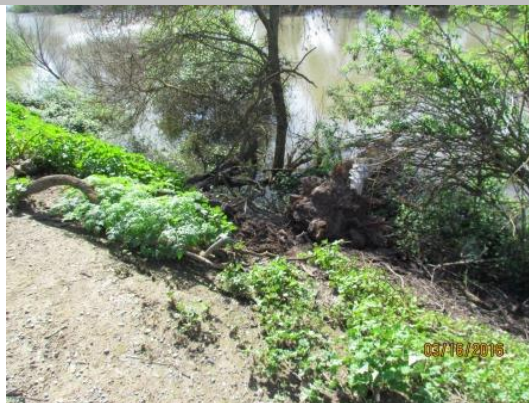
Photo 1 of 1 : SP\_2016\_RD0150\_17\_96\_20160321\_00149.jpg

LM Start	5.32	Rating **	M	Issue No.	96
LM End	5.32	Issue Type +	Ma	Location *	WS
Category	Earthen Levee			GPS Latitude/Longitude	
				Start	End
Item	Encroachments			38.381843 °	38.381843 °
				-121.543117 °	-121.543117 °
DWR ID	DWR_RD0150_03_s_2016_96				
Comment Code					
TR : Tree or limb					
Inspector Comment					
Broken tree/root damaged levee slope.

Broken tree roots and tree trunks were found on the waterside toe of the levee.

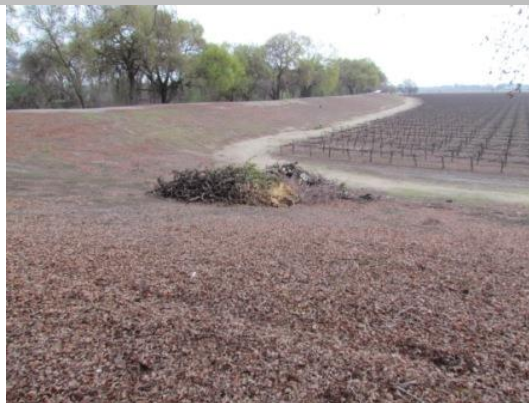
Photo 1 of 4 : SP\_2016\_RD0150\_17\_12\_20160219\_00009.jpg

LM Start	5.51	Rating **	M	Issue No.	12
LM End	5.51	Issue Type +	En	Location *	LS
Category	Earthen Levee			GPS Latitude/Longitude	
				Start	End
Item	Encroachments			38.383328 °	38.383328 °
				-121.545825 °	-121.545825 °
DWR ID	DWR_RD0150_03_s_2012_12				
Comment Code					
PR : Prunings					
Inspector Comment

Prunings were found on the landside of the levee looking upstream.

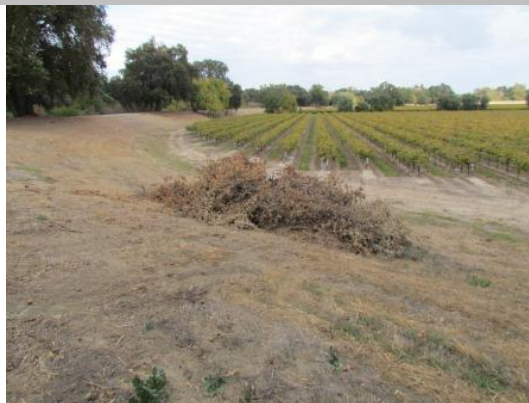
Photo 2 of 4 : SP\_2016\_RD0150\_17\_12\_20160219\_00010.jpg

Updated picture of pruning pile on the landside toe of the levee looking upstream during the fall 2013 inspection.

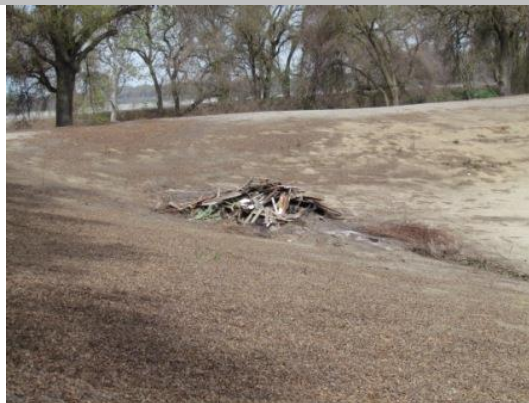
Photo 3 of 4 : SP\_2016\_RD0150\_17\_12\_20160219\_00011.jpg

Updated picture of debris and pruning on the landside toe of the levee looking upstream. This picture was taken during spring 2013 inspection.

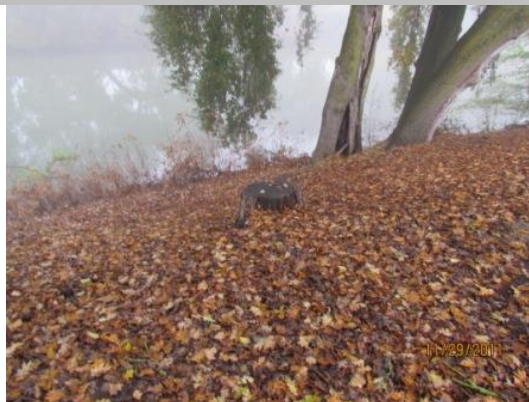
Photo 1 of 1 : SP\_2016\_RD0150\_17\_68\_20160219\_00067.jpg

LM Start	5.56	Rating **	N	Issue No.	68
LM End	5.56	Issue Type +	Ma	Location *	WS
Category	Earthen Levee			GPS Latitude/Longitude	
				Start	End
Item	Trim / Thin Trees			38.383697 °	38.383697 °
				-121.545201 °	-121.545201 °
DWR ID	DWR_RD0150_03_s_2012_68				
Comment Code					
T5 : Tree stumps.					
Inspector Comment

Tree stump was found on the waterside of the levee looking upstream.

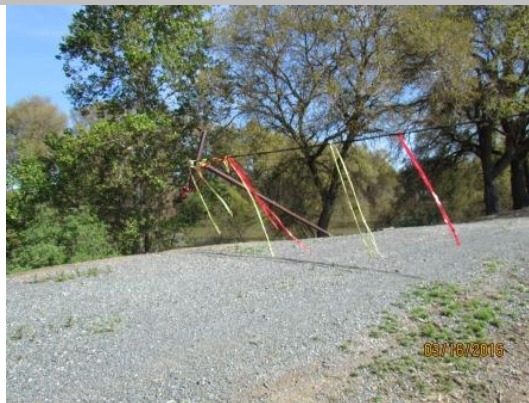
Photo 1 of 1 : SP\_2016\_RD0150\_17\_97\_20160321\_00150.jpg

LM Start	5.69	Rating **	U	Issue No.	97
LM End	5.69	Issue Type +	En	Location *	CR
Category	Earthen Levee			GPS Latitude/Longitude	
				Start	End
Item	Encroachments			38.383958 °	38.383958 °
				-121.542830 °	-121.542830 °
DWR ID	DWR_RD0150_03_s_2016_97				
Comment Code					
PO : Pole					
Inspector Comment					
A broken electrical pole with electric wire was blocking the access on the levee crown.

A broken electrical pole was blocking the accessibility on the levee crown. The picture was taken from landside slope of the levee looking upstream.

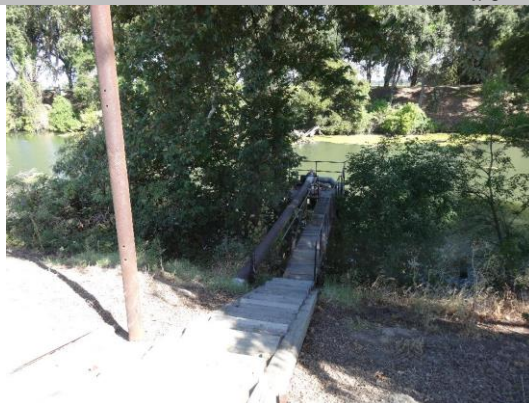
Photo 1 of 2 : UCIP\_SP\_2016\_28265\_51974.jpg

LM Start	5.70	Rating **	M	Issue No.	957
LM End	5.70	Issue Type +	En	Location *	WS
Category	Supplemental			GPS Latitude/Longitude	
				Start	End
Item	DWR UCIP Field Study			38.383996 °	38.383996 °
				-121.542638 °	-121.542638 °
DWR ID					
Comment Code					
Inspector Comment					
FS_ID:28265 DS_ID:22448 EP_NO: N/A Repair Type: Non-Urgent Crossing Status: Found UCIP Comments: - levee toe cut out at open end of the pipe.- service pole and control box on river bank. FIELD_STRUCT_DESC: 10-inch steel pipe through the levee, 7.8 feet below crown. Pump and gate valve on steel platform. Cross fence, wire drag gate. (Permit No. 1167, D. Conner) O&M Manual SAC 112, March 1957. FS Date: 8/23/2013

WS view: walkway, pipe, pump and support deck on river bank.

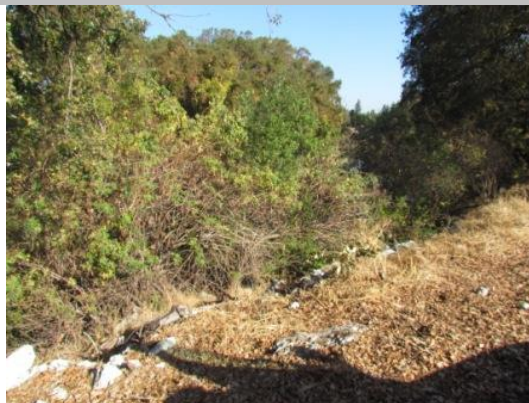
Photo 1 of 1 : SP\_2016\_RD0150\_17\_28\_20160219\_00021.jpg

LM Start	5.78	Rating **	M	Issue No.	28
LM End	5.78	Issue Type +	Ma	Location *	WS
Category	Earthen Levee			GPS Latitude/Longitude	
				Start	End
Item	Vegetation			38.384333 °	38.384333 °
				-121.541310 °	-121.541310 °
DWR ID	DWR_RD0150_03_s_2012_28				
Comment Code					
V2 : Remove the wild growth other than native grasses from the levee slopes.					
Inspector Comment

Wild growth was found on the waterside slope of the levee looking upstream.

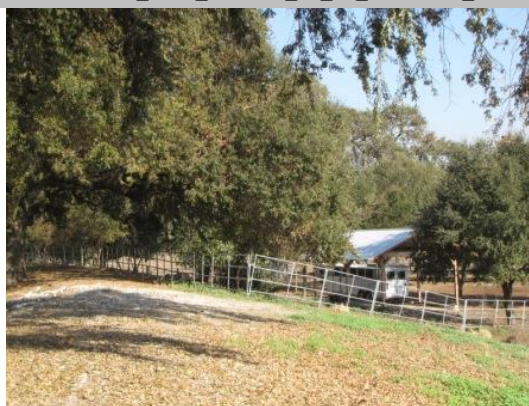
Photo 1 of 1 : SP\_2016\_RD0150\_17\_56\_20160219\_00052.jpg

LM Start	5.79	Rating **	M	Issue No.	56
LM End	5.83	Issue Type +	En	Location *	LS
Category	Earthen Levee			GPS Latitude/Longitude	
				Start	End
Item	Encroachments			38.384363 °	38.384796 °
				-121.541161 °	-121.540525 °
DWR ID	DWR_RD0150_03_s_2012_56				
Comment Code					
FE : Fence					
Inspector Comment

View of fence around a horse pen along the shoulder of the levee and the landward slope.

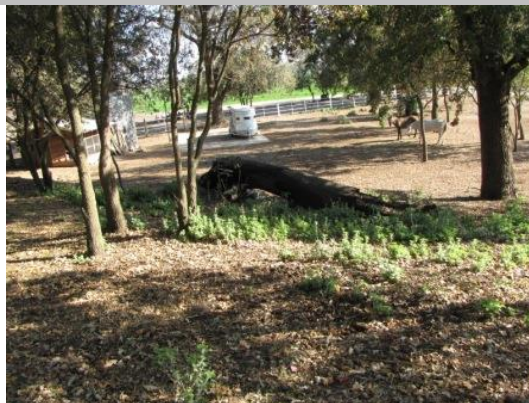
Photo 1 of 1 : SP\_2016\_RD0150\_17\_57\_20160219\_00053.jpg

LM Start	5.82	Rating **	M	Issue No.	57
LM End	5.82	Issue Type +	Ma	Location *	LS
Category	Earthen Levee			GPS Latitude/Longitude	
				Start	End
Item	Encroachments			38.384648 °	38.384648 °
				-121.540669 °	-121.540669 °
DWR ID	DWR_RD0150_03_s_2012_57				
Comment Code					
TR : Tree or limb					
Inspector Comment

View of a tree trunk lying on the landward slope blocking visibility.

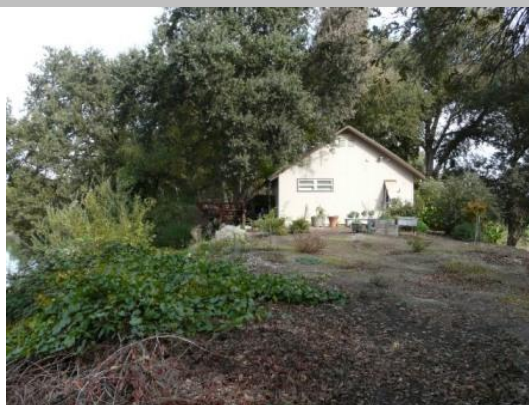
Photo 1 of 1 : SP\_2016\_RD0150\_17\_58\_20160219\_00054.jpg

LM Start	5.83	Rating **	U	Issue No.	58
LM End	5.83	Issue Type +	En	Location *	CR
Category	Earthen Levee			GPS Latitude/Longitude	
				Start	End
Item	Encroachments			38.384803 °	38.384803 °
				-121.540545 °	-121.540545 °
DWR ID	DWR_RD0150_03_s_2012_58				
Comment Code					
BU : Building					
Inspector Comment

Building &amp; associated landscaping on levee crown.

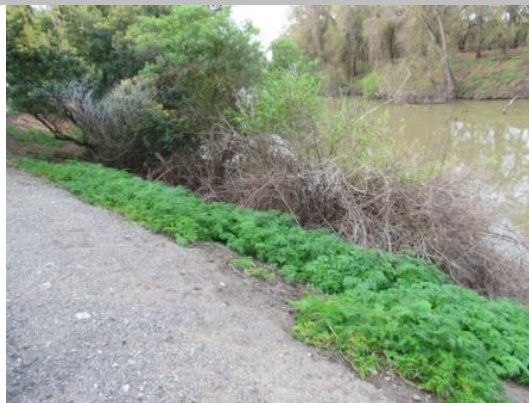
Photo 1 of 1 : SP\_2016\_RD0150\_17\_33\_20160219\_00026.jpg

LM Start	5.95	Rating **	M	Issue No.	33
LM End	5.95	Issue Type +	Ma	Location *	WS
Category	Earthen Levee			GPS Latitude/Longitude	
				Start	End
Item	Trim / Thin Trees			38.386351 °	38.386351 °
				-121.539828 °	-121.539828 °
DWR ID	DWR_RD0150_03_s_2012_33				
Comment Code					
T2 : Thin trees to allow visibility of the ground and room to flood fight.					
Inspector Comment

Tree trunks and vegetation was obstructing the visibility on the waterside slope of the levee looking downstream.

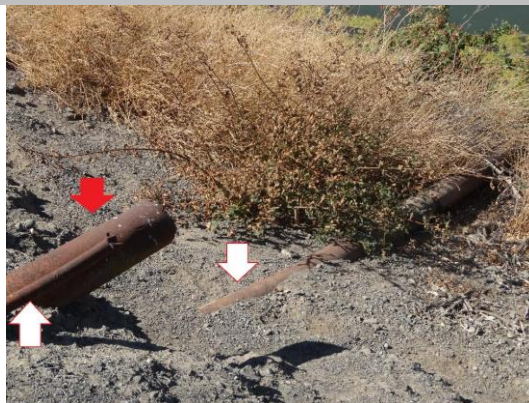
Photo 1 of 2 : UCIP\_SP\_2016\_19403\_32942.jpg

LM Start	5.95	Rating **	M	Issue No.	955
LM End	5.95	Issue Type +	En	Location *	WS
Category	Supplemental			GPS Latitude/Longitude	
				Start	End
Item	DWR UCIP Field Study			38.386402 °	38.386402 °
				-121.539834 °	-121.539834 °
DWR ID					
Comment Code					
Inspector Comment					
FS_ID:19403					
DS_ID:22451					
EP_NO: N/A					
Repair Type: Non-Urgent					
Crossing Status: Found					
UCIP Comments: - pipe ends open on both sides of the levee.- abandoned concrete box on WS.- two abandoned steel pipes (6" and 1") also found on WS. - needs proper abandonment					
FIELD_STRUCT_DESC: Abandoned 6-inch steel pipe through the levee, 2.5 feet below the crown. Power pole on the landward slope. (W. Bogle). O&M Manual SAC 112, March 1957.					
FS Date: 8/23/2013

WS view: open ended 6" steel pipe (top-left), 1" steel pipe (bottom), and another 6" steel pipe (right) on levee slope.

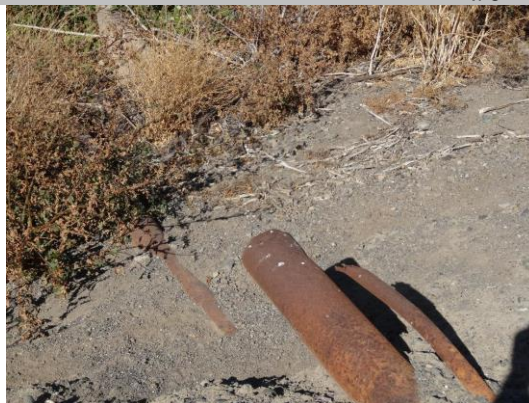
Photo 2 of 2 : UCIP\_SP\_2016\_19403\_32941.jpg

LM Start	5.95	Rating **	M	Issue No.	955 (cont)	
LM End	5.95	Issue Type +	En	Location *	WS	
Category	Supplemental			GPS Latitude/Longitude		
				Start	End	
Item	DWR UCIP Field Study			38.386402 °	38.386402 °	
				-121.539834 °	-121.539834 °	
DWR ID						
Comment Code						
Inspector Comment						
FS_ID:19403						
DS_ID:22451						
EP_NO: N/A						
Repair Type: Non-Urgent						
Crossing Status: Found						
UCIP Comments: - pipe ends open on both sides of the levee.- abandoned concrete box on WS.- two abandoned steel pipes (6" and 1") also found on WS. - needs proper abandonment						
FIELD_STRUCT_DESC: Abandoned 6-inch steel pipe through the levee, 2.5 feet below the crown. Power pole on the landward slope. (W. Bogle). O&M Manual SAC 112, March 1957.						
FS Date: 8/23/2013

WS view: Abandoned concrete box (top). Open ended 6" steel pipe, 1" steel pipe, and another 6" steel pipe on levee slope.

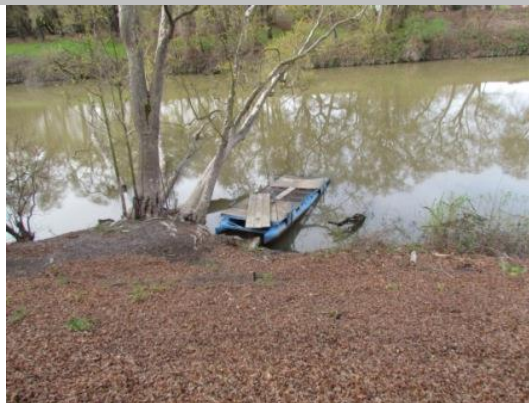
Photo 1 of 1 : SP\_2016\_RD0150\_17\_44\_20160219\_00037.jpg

LM Start	6.03	Rating **	M	Issue No.	44
LM End	6.03	Issue Type +	En	Location *	WS
Category	Earthen Levee			GPS Latitude/Longitude	
				Start	End
Item	Encroachments			38.387295 °	38.387295 °
				-121.540612 °	-121.540612 °
DWR ID	DWR_RD0150_03_s _ 2012_44				
Comment Code					
AV : Abandoned vehicles					
Inspector Comment					
It appeared to be an abandoned dock.

An abandoned dock was found on the waterside of the levee looking upstream.

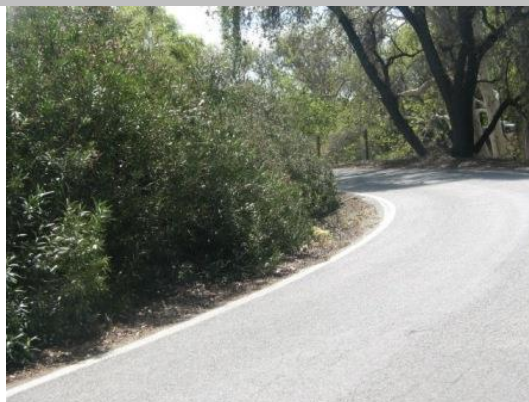
Photo 1 of 1 : SP\_2016\_RD0150\_17\_24\_20160219\_00018.jpg

LM Start	6.13	Rating **	U	Issue No.	24
LM End	6.20	Issue Type +	En	Location *	LS
Category	Earthen Levee			GPS Latitude/Longitude	
				Start	End
Item	Vegetation			38.388535 °	38.389391 °
				-121.541657 °	-121.541901 °
DWR ID	DWR_RD0150_03_s _ 2012_24				
Comment Code					
V6 : Landscaping					
Inspector Comment

Oleander on landward slope blocking view of levee.

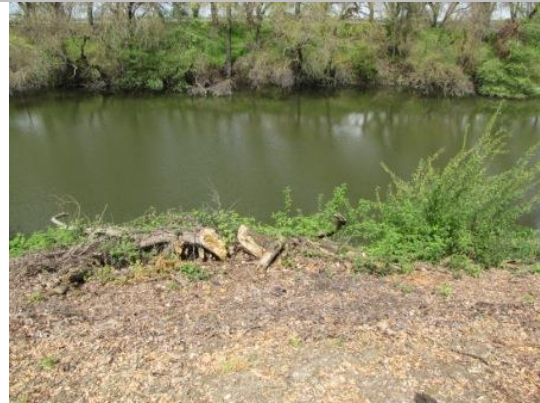
Photo 1 of 1 : SP\_2016\_RD0150\_17\_49\_20160219\_00042.jpg

LM Start	6.23	Rating **	N	Issue No.	49
LM End	6.23	Issue Type +	Ma	Location *	WS
Category	Earthen Levee			GPS Latitude/Longitude	
				Start	End
Item	Trim / Thin Trees			38.389658 °	38.389658 °
				-121.541518 °	-121.541518 °
DWR ID	DWR_RD0150_03_s_2012_49				
Comment Code					
T5 : Tree stumps.					
Inspector Comment

View of tree stumps on the waterward slope.

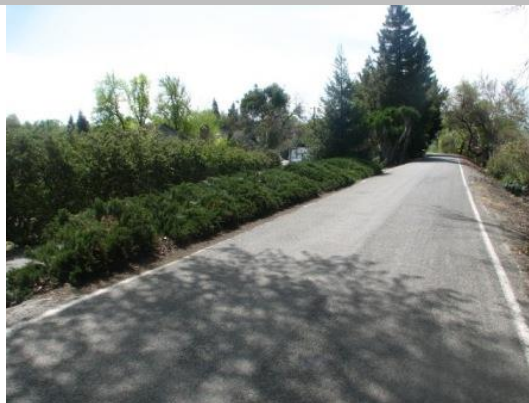
Photo 1 of 1 : SP\_2016\_RD0150\_17\_26\_20160219\_00019.jpg

LM Start	6.25	Rating **	U	Issue No.	26
LM End	6.29	Issue Type +	En	Location *	LS
Category	Earthen Levee			GPS Latitude/Longitude	
				Start	End
Item	Vegetation			38.389858 °	38.390115 °
				-121.541155 °	-121.540657 °
DWR ID	DWR_RD0150_03_s_2012_26				
Comment Code					
V6 : Landscaping					
Inspector Comment

Landscaping on landward slope.

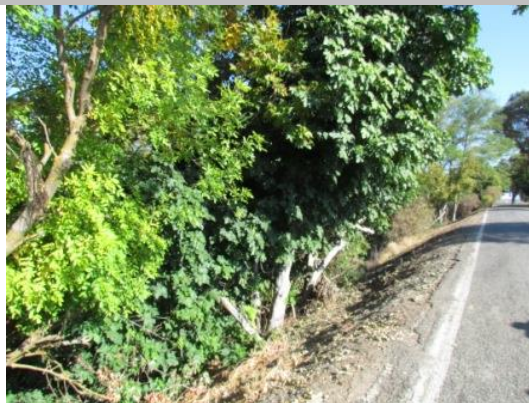
Photo 1 of 2 : SP\_2016\_RD0150\_17\_62\_20160219\_00059.jpg

LM Start	6.38	Rating **	U	Issue No.	62
LM End	6.38	Issue Type +	Ma	Location *	WS
Category	Earthen Levee			GPS Latitude/Longitude	
				Start	End
Item	Trim / Thin Trees			38.390935 °	38.390935 °
				-121.539369 °	-121.539369 °
DWR ID	DWR_RD0150_03_s_2012_62				
Comment Code					
T3 : Trim and thin trees to allow visibility of the ground and room to flood fight.					
Inspector Comment

Tree was blocking the visibility on the waterside of the levee looking upstream. This picture was taken during fall 2012 inspection.

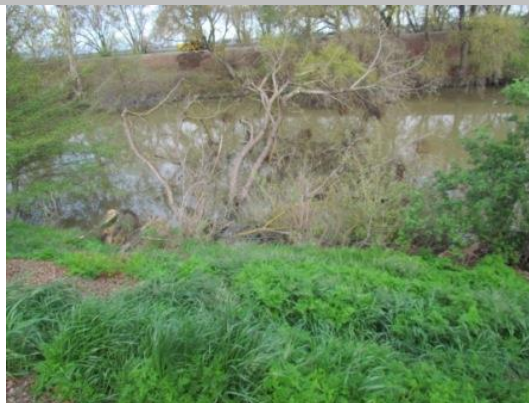
Photo 2 of 2 : SP\_2016\_RD0150\_17\_62\_20160219\_00060.jpg

Vegetation on the waterside of the levee looking downstream.

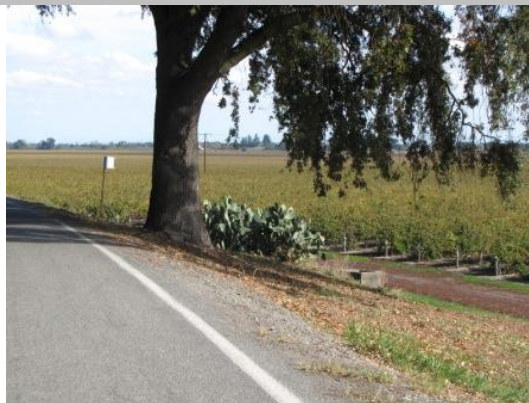
Photo 1 of 1 : SP\_2016\_RD0150\_17\_60\_20160219\_00056.jpg

LM Start	6.45	Rating **	M	Issue No.	60
LM End	6.45	Issue Type +	En	Location *	LS
Category	Earthen Levee			GPS Latitude/Longitude	
				Start	End
Item	Vegetation			38.391616 °	38.391616 °
				-121.538378 °	-121.538378 °
DWR ID	DWR_RD0150_03_s_2012_60				
Comment Code					
V6 : Landscaping					
Inspector Comment

View of landscaping along the landward slope.

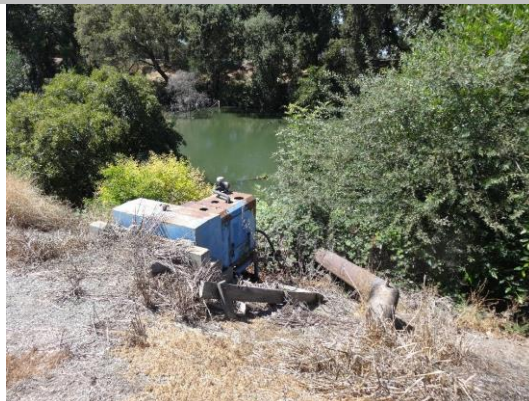
Photo 1 of 2 : UCIP\_SP\_2016\_42692\_35082.jpg

LM Start	6.63	Rating **	M	Issue No.	962
LM End	6.63	Issue Type +	En	Location *	LS
Category	Supplemental			GPS Latitude/Longitude	
				Start	End
Item	DWR UCIP Field Study			38.394182 °	38.394182 °
				-121.538609 °	-121.538609 °
DWR ID					
Comment Code					
Inspector Comment					
FS_ID:42692					
DS_ID:22457					
EP_NO: 14650					
Repair Type: Non-Urgent					
Crossing Status: Found					
UCIP Comments: Appears abandoned and if so should be done so properly.					
FIELD_STRUCT_DESC: 12-inch steel irrigation pipe through the levee, 5 feet below the crown. Concrete distribution box on landside levee toe.					
Diesel powered slant pump on water side. (Permit No. 14650 - Webber)					
FS Date: 8/23/2013

WS view: steel pipe (right) and diesel pump on levee slope.

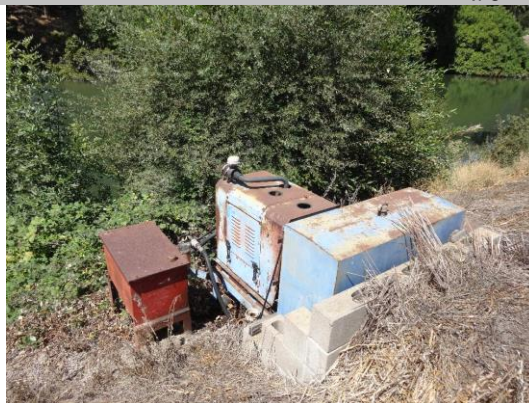
Photo 2 of 2 : UCIP\_SP\_2016\_42692\_35081.jpg

WS view: diesel pump on steep levee slope.

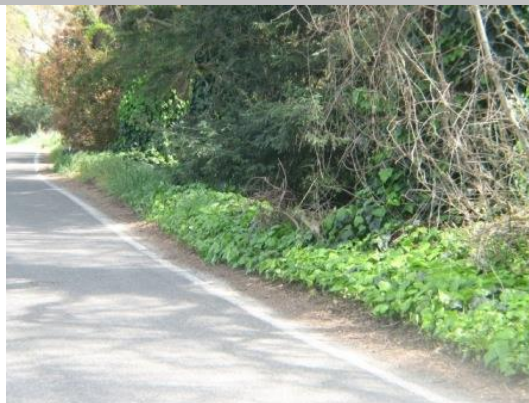
Photo 1 of 1 : SP\_2016\_RD0150\_17\_30\_20160219\_00022.jpg

LM Start	6.75	Rating **	U	Issue No.	30
LM End	6.83	Issue Type +	En	Location *	LS
Category	Earthen Levee			GPS Latitude/Longitude	
				Start	End
Item	Vegetation			38.395670 °	38.396027 °
				-121.537925 °	-121.536575 °
DWR ID	DWR_RD0150_03_s_2012_30				
Comment Code					
V6 : Landscaping					
Inspector Comment

Landscaping on landward slope blocking view from LM 6.87 to 6.95

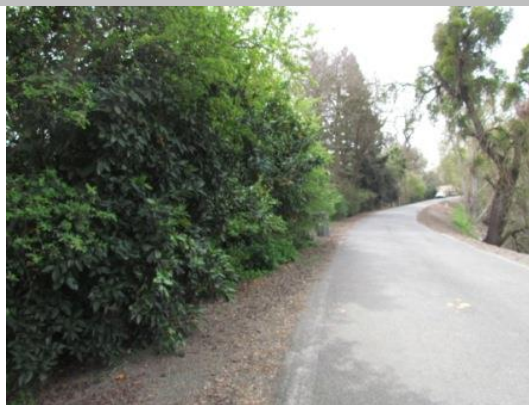
Photo 1 of 1 : SP\_2016\_RD0150\_17\_933\_20160219\_00093.jpg

LM Start	6.85	Rating **	U	Issue No.	933
LM End	6.93	Issue Type +	En	Location *	LS
Category	Earthen Levee			GPS Latitude/Longitude	
				Start	End
Item	Vegetation			38.396187 °	38.396989 °
				-121.536180 °	-121.535151 °
DWR ID	DWR_RD0150_03_s_2012_933				
Comment Code					
V6 : Landscaping					
Inspector Comment					
Landscaping has been maintained better, but some obstructions still exist.

View of the landscape on the landside shoulder of the levee looking downstream.

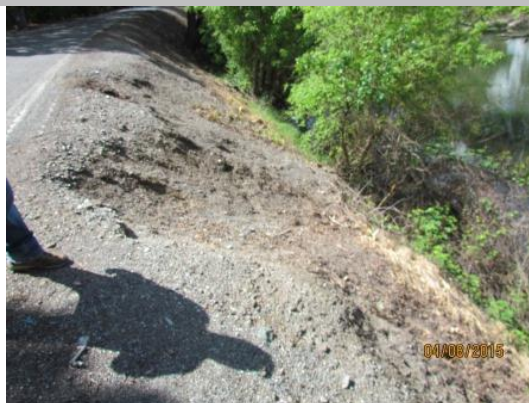
Photo 1 of 2 : SP\_2016\_RD0150\_17\_61\_20160219\_00057.jpg

LM Start	6.90	Rating **	M	Issue No.	61
LM End	6.90	Issue Type +	Ma	Location *	WS
Category	Earthen Levee			GPS Latitude/Longitude	
				Start	End
Item	Erosion / Bank Caving			38.396655 °	38.396655 °
				-121.535485 °	-121.535485 °
DWR ID	DWR_RD0150_03_s_2012_61				
Comment Code					
E1 : Note and monitor erosion site.					
Inspector Comment

Updated picture of the erosion on the waterside of the levee during spring 2015 inspection.

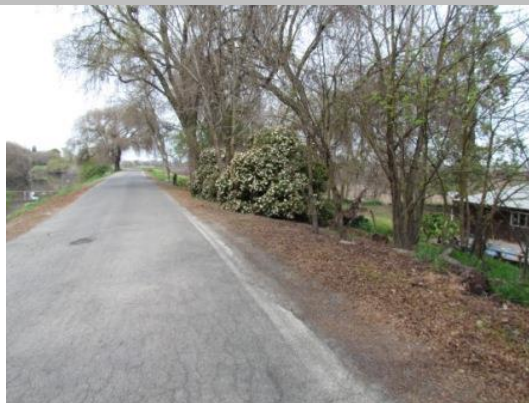
Photo 1 of 1 : SP\_2016\_RD0150\_17\_31\_20160219\_00023.jpg

LM Start	6.93	Rating **	M	Issue No.	31
LM End	6.97	Issue Type +	En	Location *	LS
Category	Earthen Levee			GPS Latitude/Longitude	
				Start	End
Item	Vegetation			38.397021 °	38.397540 °
				-121.535151 °	-121.535183 °
DWR ID	DWR_RD0150_03_s_2012_31				
Comment Code					
V6 : Landscaping					
Inspector Comment

Landscaping was found on the landside shoulder of the levee looking upstream.

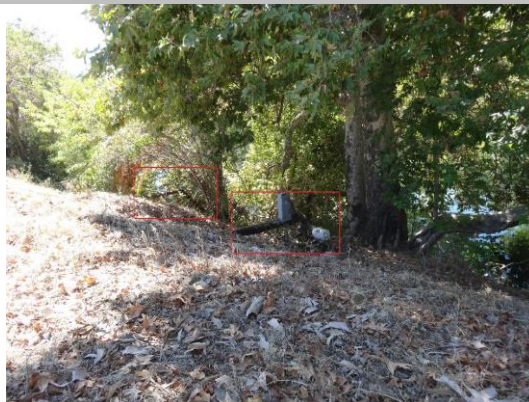
Photo 1 of 2 : UCIP\_SP\_2016\_42689\_33582.jpg

LM Start	7.21	Rating **	U	Issue No.	961
LM End	7.21	Issue Type +	En	Location *	LS
Category	Supplemental			GPS Latitude/Longitude	
				Start	End
Item	DWR UCIP Field Study			38.400883 °	38.400883 °
				-121.536200 °	-121.536200 °
DWR ID					
Comment Code					
Inspector Comment					
FS_ID:42689 DS_ID:22463 EP_NO: N/A Repair Type: Urgent Crossing Status: Found UCIP Comments: - Safety valve on pipe on waterside.- Power pole on waterside.- gully formation (erosion) on waterside levee slope FIELD_STRUCT_DESC: 8-inch steel pipe through the levee, 7.7 feet below the crown, pump and gate valve on the waterward slope. Power pole on waterside. O&M Manual Sac 112, March 1957. FS Date: 8/23/2013

WS view: 8-inch pipe and pump on levee slope (right)

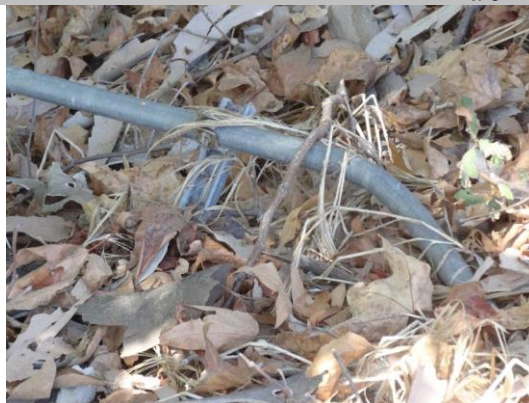
Photo 2 of 2 : UCIP\_SP\_2016\_42689\_33581.jpg

LM Start	7.21	Rating **	U	Issue No.	961 (cont)	
LM End	7.21	Issue Type +	En	Location *	LS	
Category	Supplemental			GPS Latitude/Longitude		
				Start	End	
Item	DWR UCIP Field Study			38.400883 °	38.400883 °	
				-121.536200 °	-121.536200 °	
DWR ID						
Comment Code						
Inspector Comment						
FS_ID:42689						
DS_ID:22463						
EP_NO: N/A						
Repair Type: Urgent						
Crossing Status: Found						
UCIP Comments: - Safety valve on pipe on waterside.- Power pole on waterside.- gully formation (erosion) on waterside levee slope						
FIELD_STRUCT_DESC: 8-inch steel pipe through the levee, 7.7 feet below the crown, pump and gate valve on the waterward slope. Power pole on waterside. O&M Manual Sac 112, March 1957.						
FS Date: 8/23/2013

WS view: electric GI conduit on levee slope.

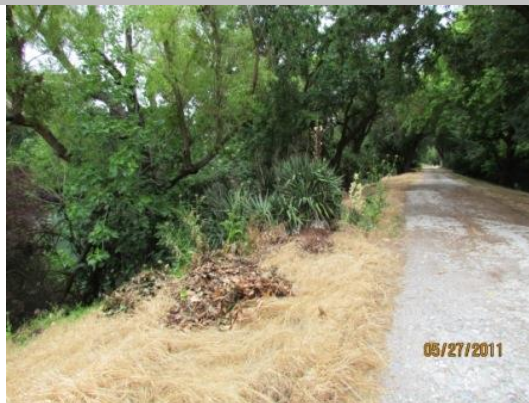
Photo 1 of 1 : SP\_2016\_RD0150\_17\_64\_20160219\_00062.jpg

LM Start	7.26	Rating **	U	Issue No.	64
LM End	7.26	Issue Type +	En	Location *	WS
Category	Earthen Levee			GPS Latitude/Longitude	
				Start	End
Item	Vegetation			38.401481 °	38.401481 °
				-121.536876 °	-121.536876 °
DWR ID	DWR_RD0150_03_s_2012_64				
Comment Code					
V6 : Landscaping					
Inspector Comment

Landscaping on the waterside of the levee. The picture was taken from the crown looking upstream.

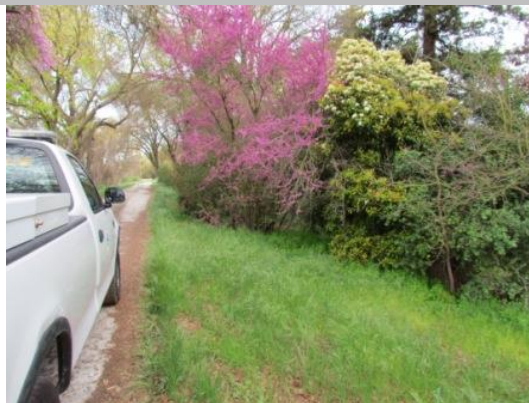
Photo 1 of 2 : SP\_2016\_RD0150\_17\_32\_20160219\_00024.jpg

LM Start	7.29	Rating **	U	Issue No.	32
LM End	7.34	Issue Type +	En	Location *	LS
Category	Earthen Levee			GPS Latitude/Longitude	
				Start	End
Item	Vegetation			38.401738 °	38.402296 °
				-121.537127 °	-121.537678 °
DWR ID	DWR_RD0150_03_s_2012_32				
Comment Code					
V6 : Landscaping					
Inspector Comment

Vegetation on the landside of the levee looking upstream. This picture was taken during spring 2012 inspection.

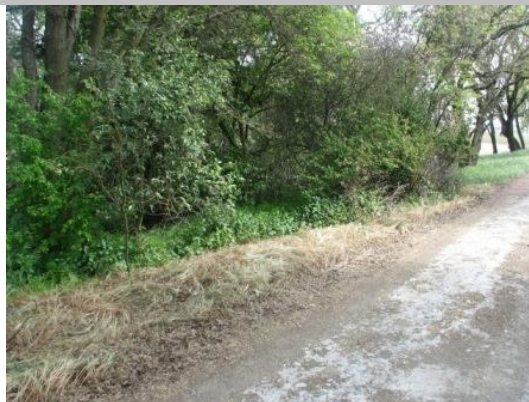
Photo 2 of 2 : SP\_2016\_RD0150\_17\_32\_20160219\_00025.jpg

LM Start	<b>7.29</b>	Rating **	U	Issue No.	<b>32 (cont)</b>
LM End	<b>7.34</b>	Issue Type +	En	Location *	LS

Landscaping on landward slope blocking view from LM 7.42 to 7.47

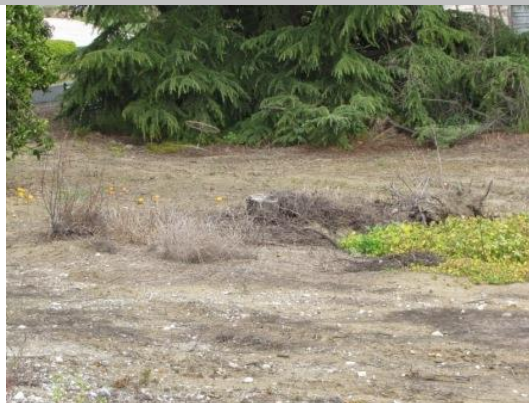
Photo 1 of 1 : SP\_2016\_RD0150\_17\_63\_20160219\_00061.jpg

LM Start	7.38	Rating **	N	Issue No.	63
LM End	7.38	Issue Type +	Ma	Location *	LS
Category	Earthen Levee			GPS Latitude/Longitude	
				Start	End
Item	Trim / Thin Trees			38.402779 °	38.402779 °
				-121.538197 °	-121.538197 °
DWR ID	DWR_RD0150_03_s_2012_63				
Comment Code					
T5 : Tree stumps.					
Inspector Comment

View of a tree stump on the landward slope.

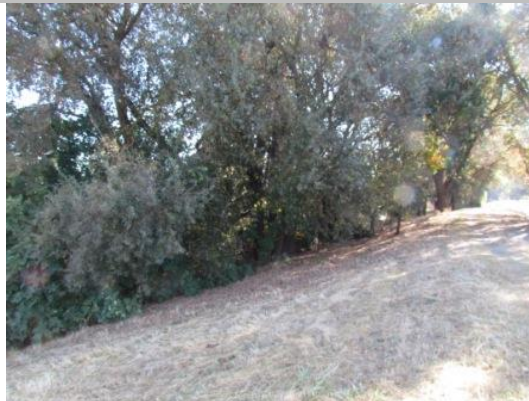
Photo 1 of 1 : SP\_2016\_RD0150\_17\_934\_20160219\_00094.jpg

LM Start	7.44	Rating **	U	Issue No.	934
LM End	7.44	Issue Type +	En	Location *	LS
Category	Earthen Levee			GPS Latitude/Longitude	
				Start	End
Item	Vegetation			38.403566 °	38.403566 °
				-121.538886 °	-121.538886 °
DWR ID	DWR_RD0150_03_s_2012_934				
Comment Code					
V6 : Landscaping					
Inspector Comment

Landscaping was blocking the visibility on the landside of the levee looking downstream.

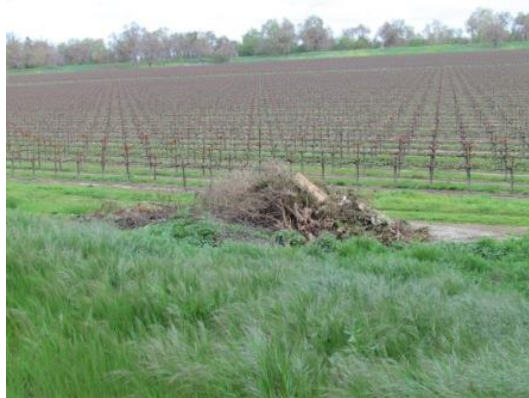
Photo 1 of 2 : SP\_2016\_RD0150\_17\_935\_20160219\_00095.jpg

LM Start	7.47	Rating **	M	Issue No.	935
LM End	7.47	Issue Type +	Ma	Location *	LS
Category	Earthen Levee			GPS Latitude/Longitude	
				Start	End
Item	Encroachments			38.403795 °	38.403795 °
				-121.539205 °	-121.539205 °
DWR ID	DWR_RD0150_03_s_2012_935				
Comment Code					
PR : Prunings					
Inspector Comment

Prunings were found on the landside of the levee looking upstream.

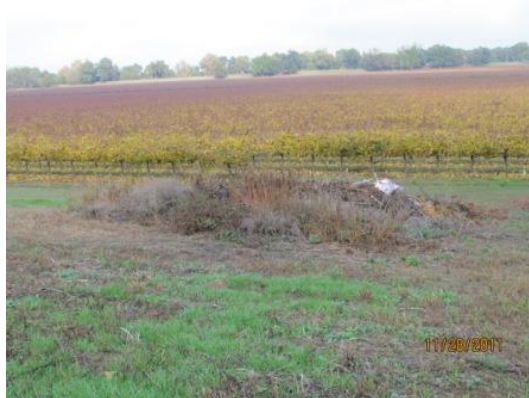
Photo 2 of 2 : SP\_2016\_RD0150\_17\_935\_20160219\_00096.jpg

LM Start	<b>7.47</b>	Rating **	M	Issue No.	<b>935 (cont)</b>
LM End	<b>7.47</b>	Issue Type +	Ma	Location *	LS

Prunings were found on the landside of the levee looking upstream. This picture was taken during fall 2011 inspection.

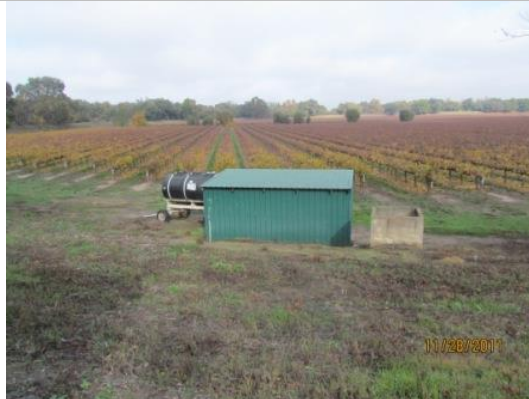
Photo 1 of 1 : SP\_2016\_RD0150\_17\_16\_20160219\_00014.jpg

LM Start	7.68	Rating **	M	Issue No.	16	
LM End	7.68	Issue Type +	En	Location *	LS	
Category	Earthen Levee			GPS Latitude/Longitude		
				Start		End
Item	Encroachments			38.405342 °	38.405342 °	
				-121.542553 °	-121.542553 °	
DWR ID	DWR_RD0150_03_s_2012_16					
Comment Code						
BU : Building						
Inspector Comment

Equipment and buiding was found on the landside of the levee looking upstream.

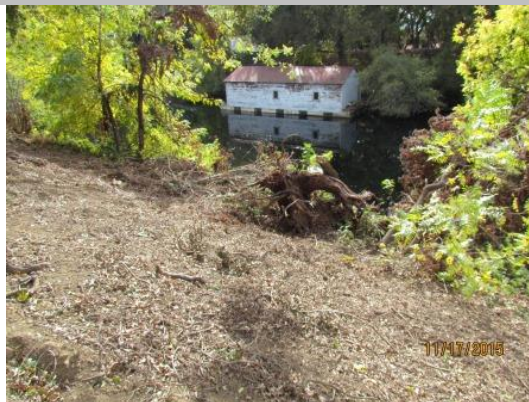
Photo 1 of 1 : SP\_2016\_RD0150\_17\_52\_20160219\_00048.jpg

LM Start	7.70	Rating **	M	Issue No.	52
LM End	7.70	Issue Type +	Ma	Location *	WS
Category	Earthen Levee			GPS Latitude/Longitude	
				Start	End
Item	Encroachments			38.405536 °	38.405536 °
				-121.542752 °	-121.542752 °
DWR ID	DWR_RD0150_03_f_2015_52				
Comment Code					
TR : Tree or limb					
Inspector Comment					
Tree trunks and stumps might damage the levee toe during high water.

View of the tree trunk on the waterside toe of the levee.

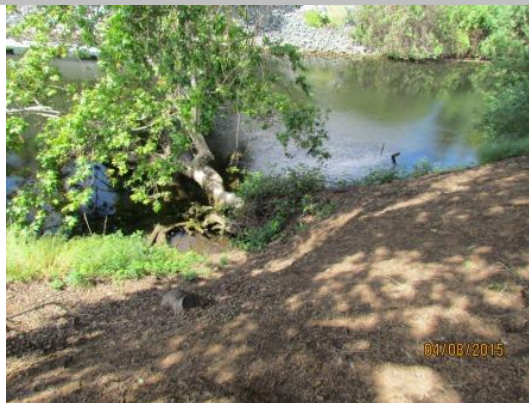
Photo 1 of 1 : SP\_2016\_RD0150\_17\_396\_20160219\_00092.jpg

LM Start	7.74	Rating **	M	Issue No.	396
LM End	7.74	Issue Type +	Ma	Location *	WS
Category	Earthen Levee			GPS Latitude/Longitude	
				Start	End
Item	Slope Stability			38.406098 °	38.406098 °
				-121.543028 °	-121.543028 °
DWR ID	DWR_RD0150_03_s_2015_396				
Comment Code					
S1 : Repair slope instability.					
Inspector Comment					
Slope instability caused by a tree.

Slope instability was found on the waterside toe of the levee looking upstream.

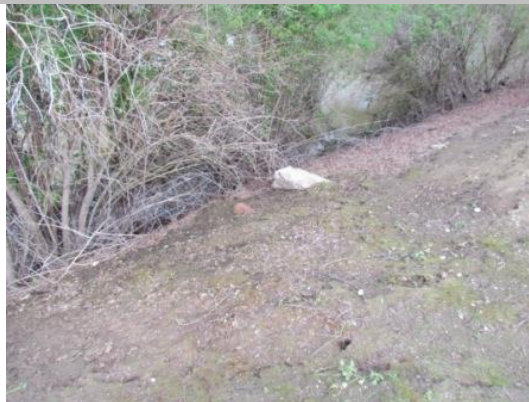
Photo 1 of 1 : SP\_2016\_RD0150\_17\_87\_20160219\_00080.jpg

LM Start	7.91	Rating **	M	Issue No.	87
LM End	7.91	Issue Type +	En	Location *	WS
Category	Earthen Levee			GPS Latitude/Longitude	
				Start	End
Item	Encroachments			38.408342 °	38.408342 °
				-121.541580 °	-121.541580 °
DWR ID	DWR_RD0150_03_s_2012_87				
Comment Code					
MA : Material					
Inspector Comment					
A concrete or anchor block was found on the slope of the levee.

A concrete block was found on the waterside of the levee looking upstream.

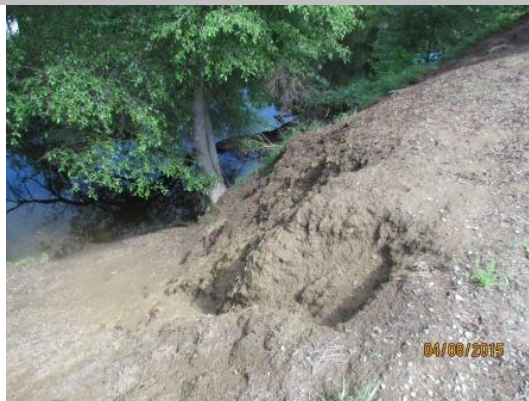
Photo 1 of 2 : SP\_2016\_RD0150\_17\_92\_20160219\_00084.jpg

LM Start	8.02	Rating **	M	Issue No.	92
LM End	8.02	Issue Type +	Ma	Location *	WS
Category	Earthen Levee			GPS Latitude/Longitude	
				Start	End
Item	Slope Stability			38.409130 °	38.409130 °
				-121.539971 °	-121.539971 °
DWR ID	DWR_RD0150_03_s_2014_92				
Comment Code					
S1 : Repair slope instability.					
Inspector Comment

Updated picture of the slope instability on the waterside of the levee looking upstream during spring 2015 inspection.

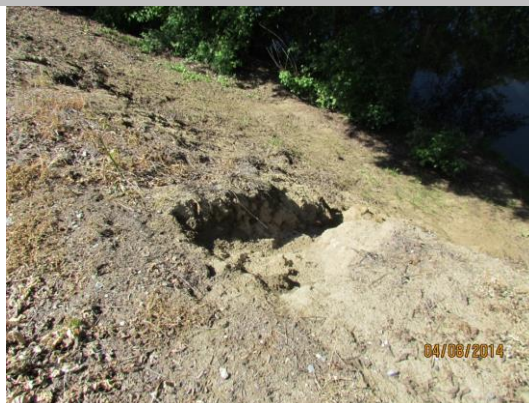
Photo 2 of 2 : SP\_2016\_RD0150\_17\_92\_20160219\_00085.jpg

LM Start	<b>8.02</b>	Rating **	M	Issue No.	<b>92 (cont)</b>
LM End	<b>8.02</b>	Issue Type +	Ma	Location *	WS

A slope instability was found on the waterside of the levee looking downstream.
